#### Test Report No. 7191251620-MEC21-LHK dated 09 APR 2021

Fire resistance test on an insulated single leaf composite doorset consisted of asymmetrical Internal timber edge stiles and rails, Brand "KNS" and Model "KNS 30 minutes" with vision pane installed within drywall partition submitted by KNS Holdings Pte Ltd.

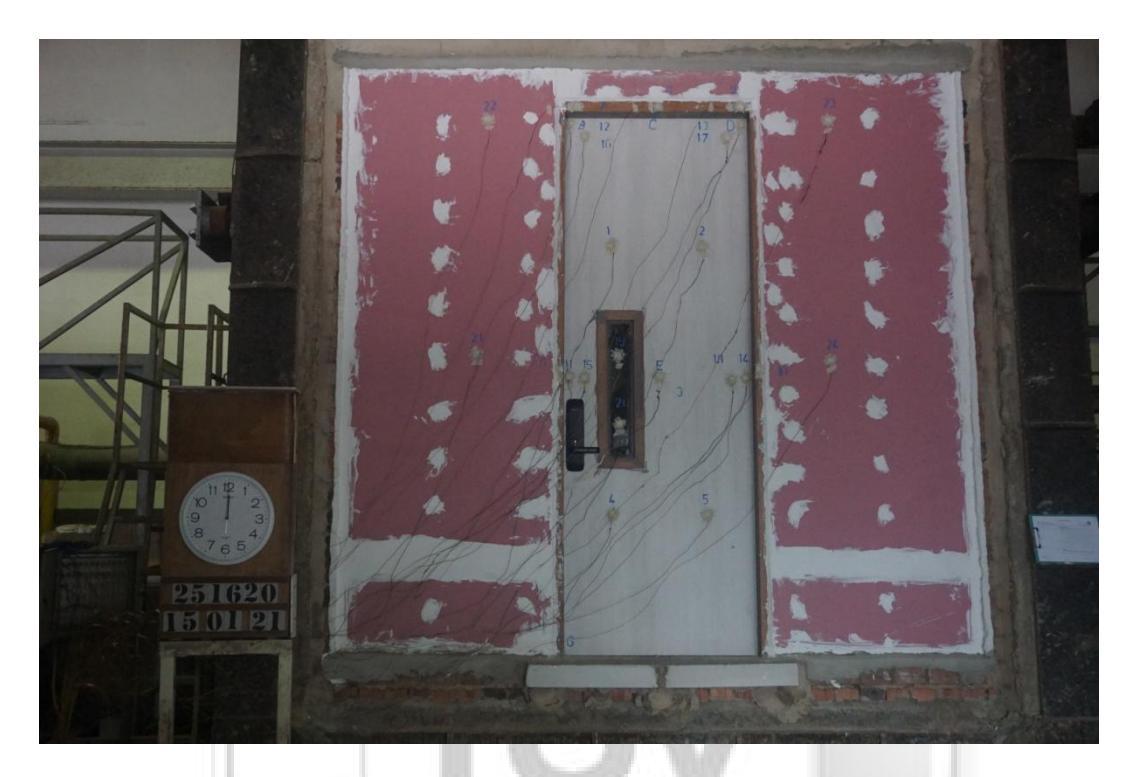
Plate 1: The unexposed face of specimen before the test.

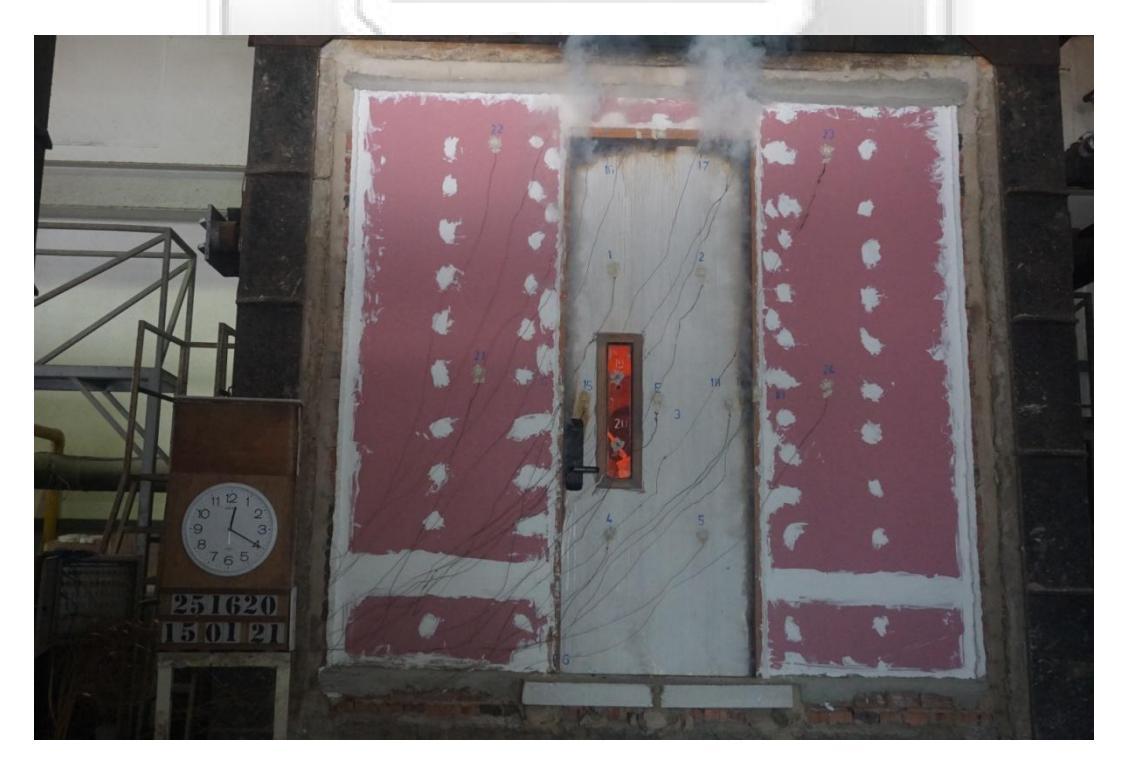
Plate 2: At about 20 minutes of test.

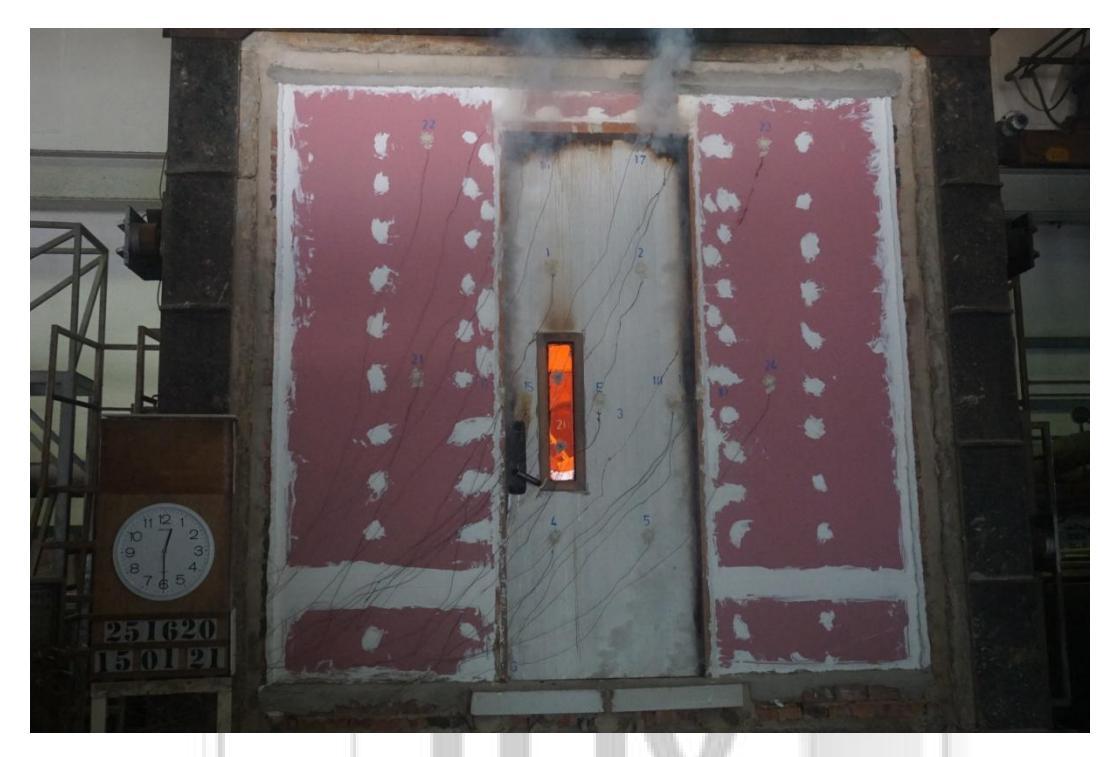
# Plate 3: At about 30 minutes of test.

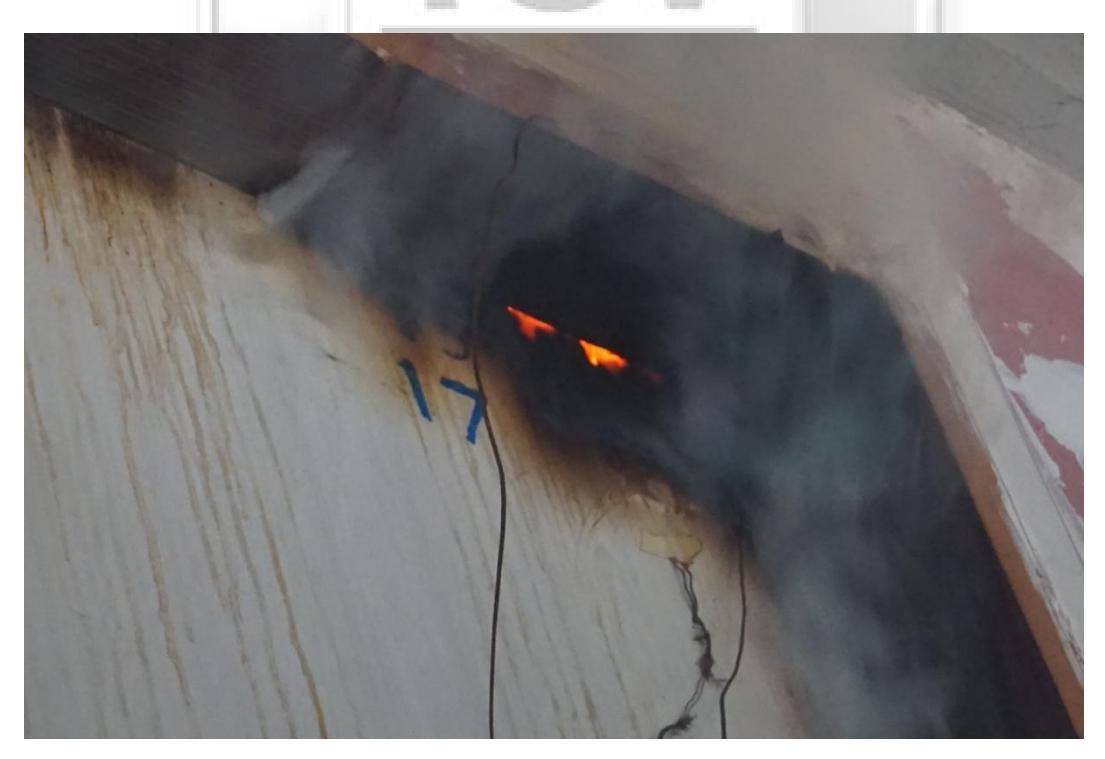
At 37 minutes and 20 seconds of test, continuous flaming was observed at top edge around concealed door closer area for more than 10 seconds and still persistence, therefore, the integrity of the specimen, meets the standard for 37 minutes.

Plate 4: Close-up view flaming at about 37 minutes and 20 seconds of test

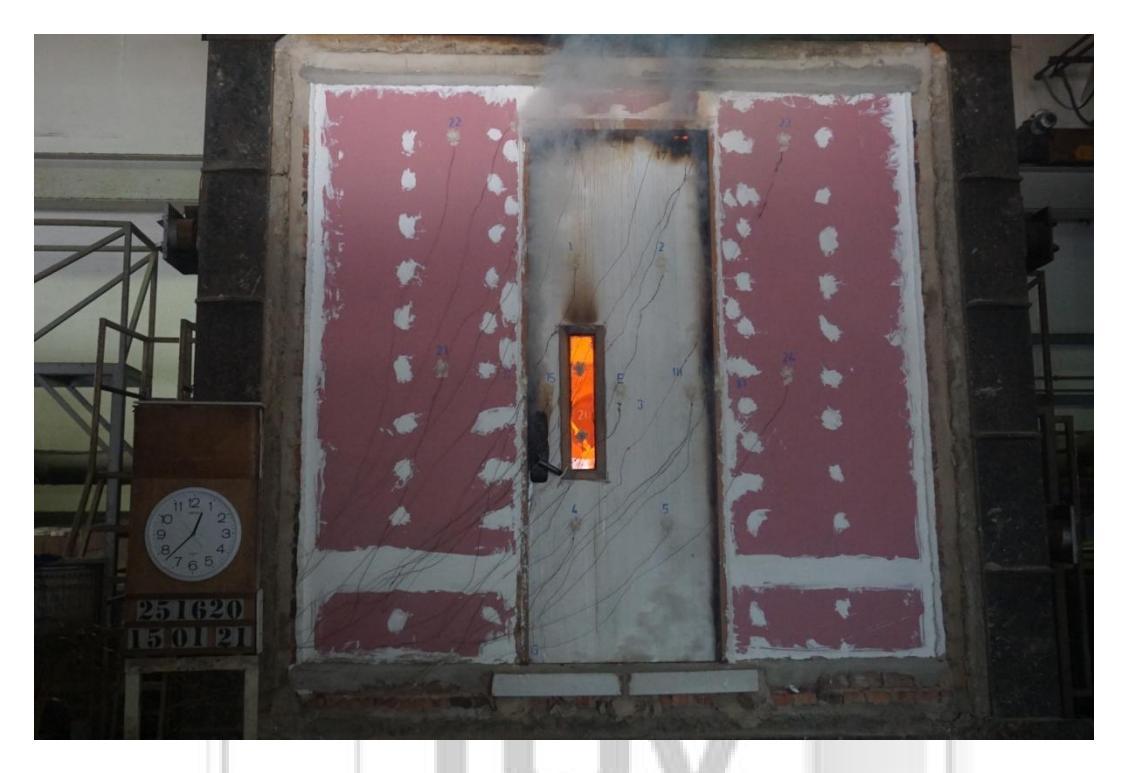
Plate 5: At about 38 minutes of test.

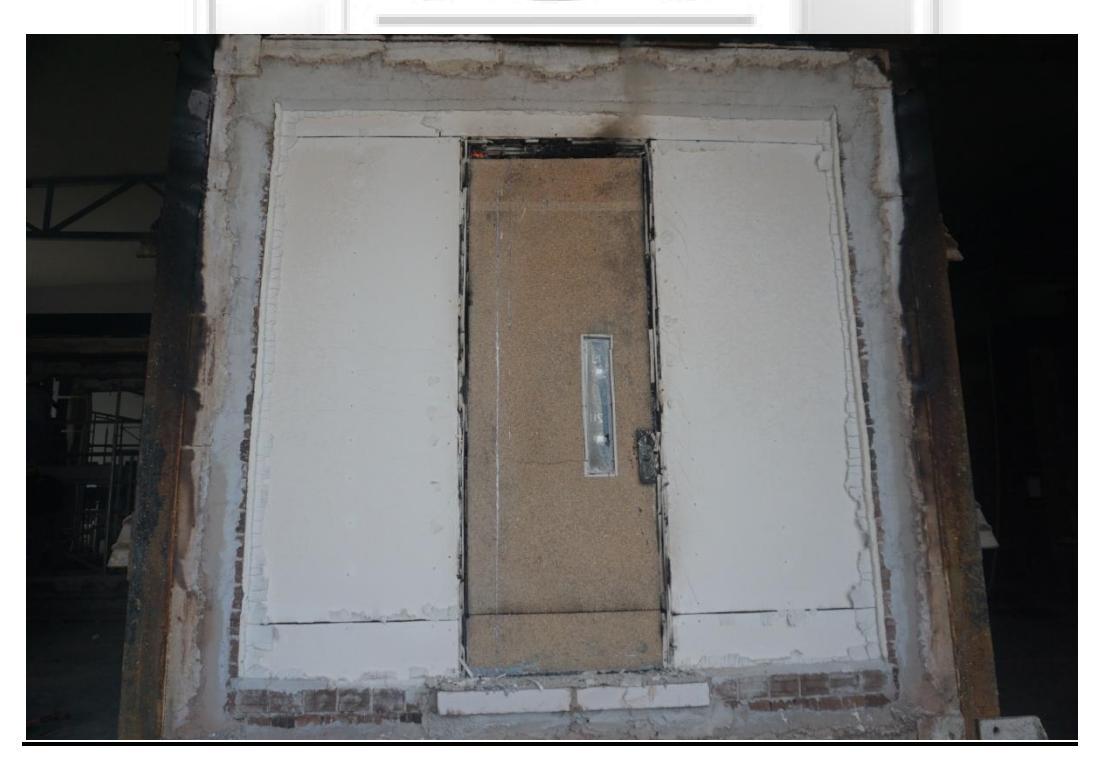
Plate 6: The exposed face of specimen after the test.
