Radiated Emission Measurement

Condition : ETSI EN300\_328-RX\_Spurious\_N

EUT : W6M21906-19111

Test Mode : RX CH39

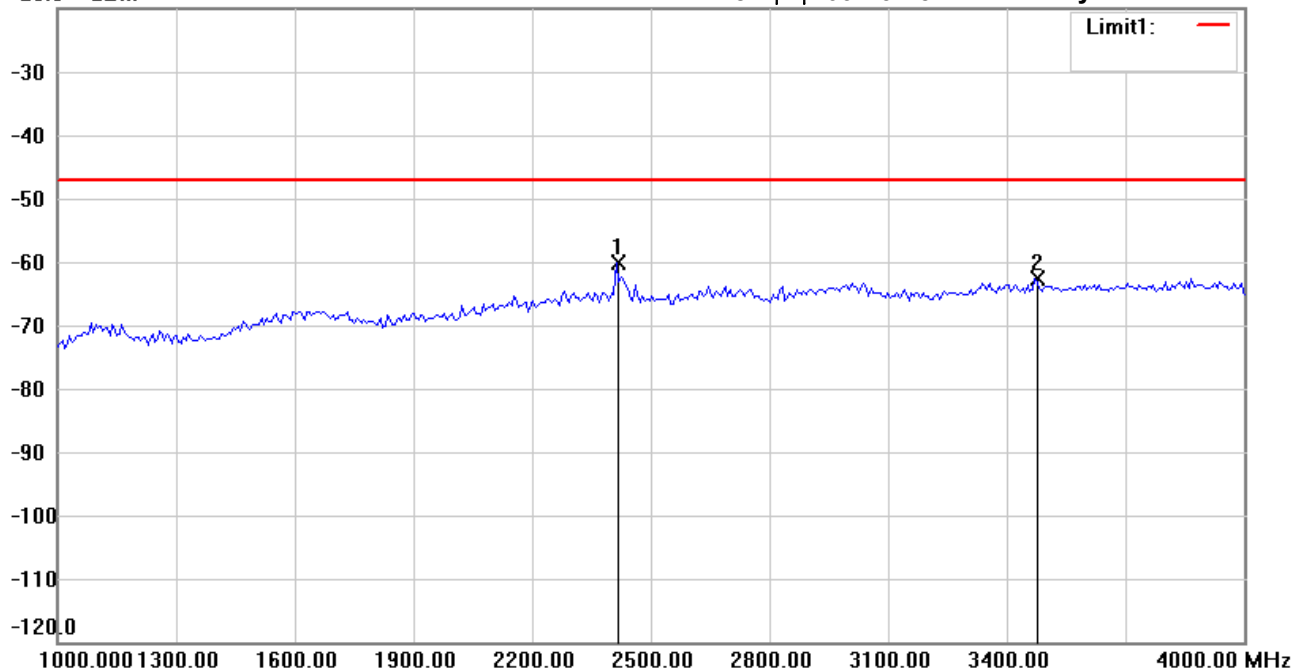
Data :#4

Site : Chamber

Polarization: **Vertical**

Distance: 3m

| Mk. | Frequency (MHz) | Reading (dBm) | Detector | Corr. factor (dB) | Result (dBm) | Limit (dBm) | Ant.Pos (cm) | Tab.Pos (deg.) | Margin (dB) | Comment |
|---|---|---|---|---|---|---|---|---|---|---|
| * | 2412.826 | -58.45 | peak | -1.71 | -60.16 | -47.00 | 150 | 320 | -13.16 | |
| | 3470.942 | -63.44 | peak | 0.72 | -62.72 | -47.00 | 150 | 120 | -15.72 | |

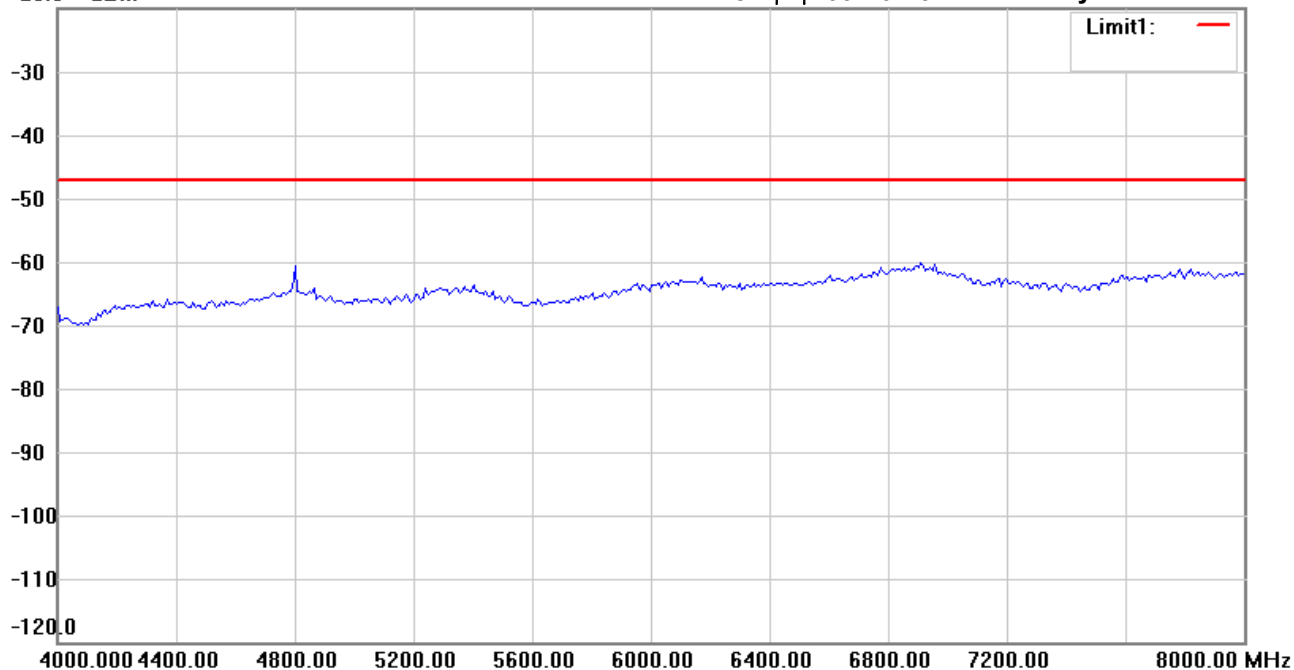
Data : #2

Condition : ETSI EN300\_328-RX\_Spurious\_N

Test Mode : RX CH39

Polarization: *Horizontal*

Distance: 3m

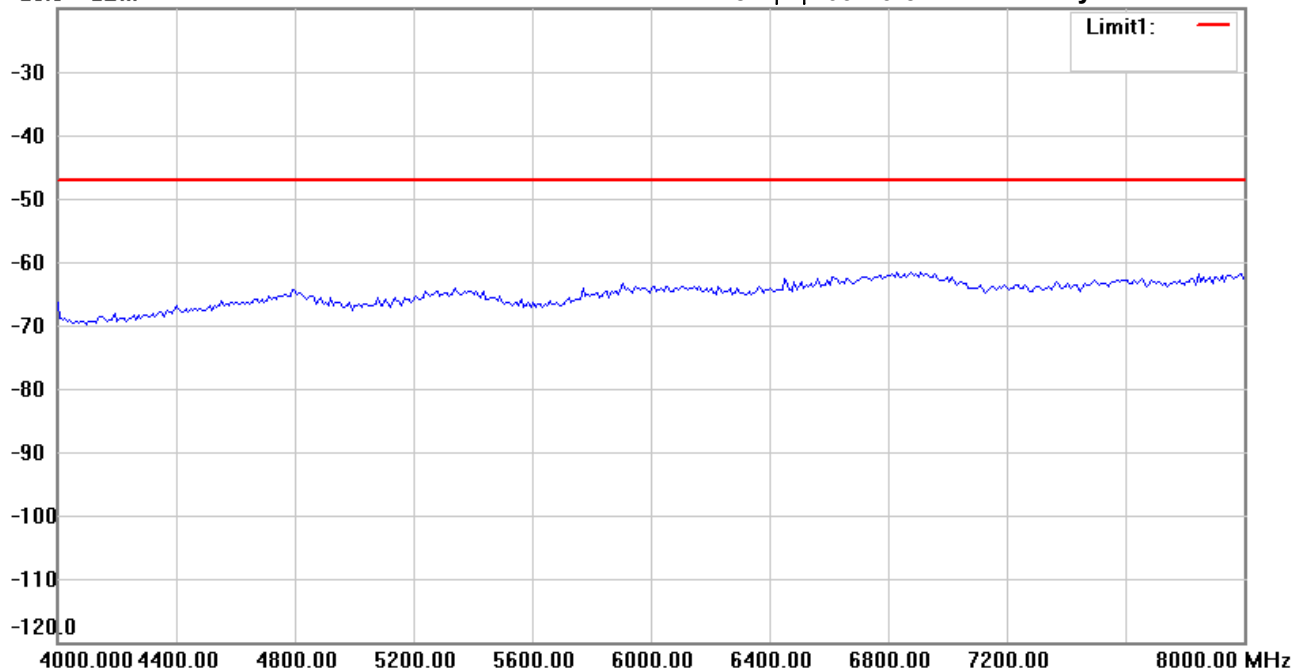
Data : #5

Condition : ETSI EN300\_328-RX\_Spurious\_N

Test Mode : RX CH39

Polarization: *Vertical*

Distance: 3m

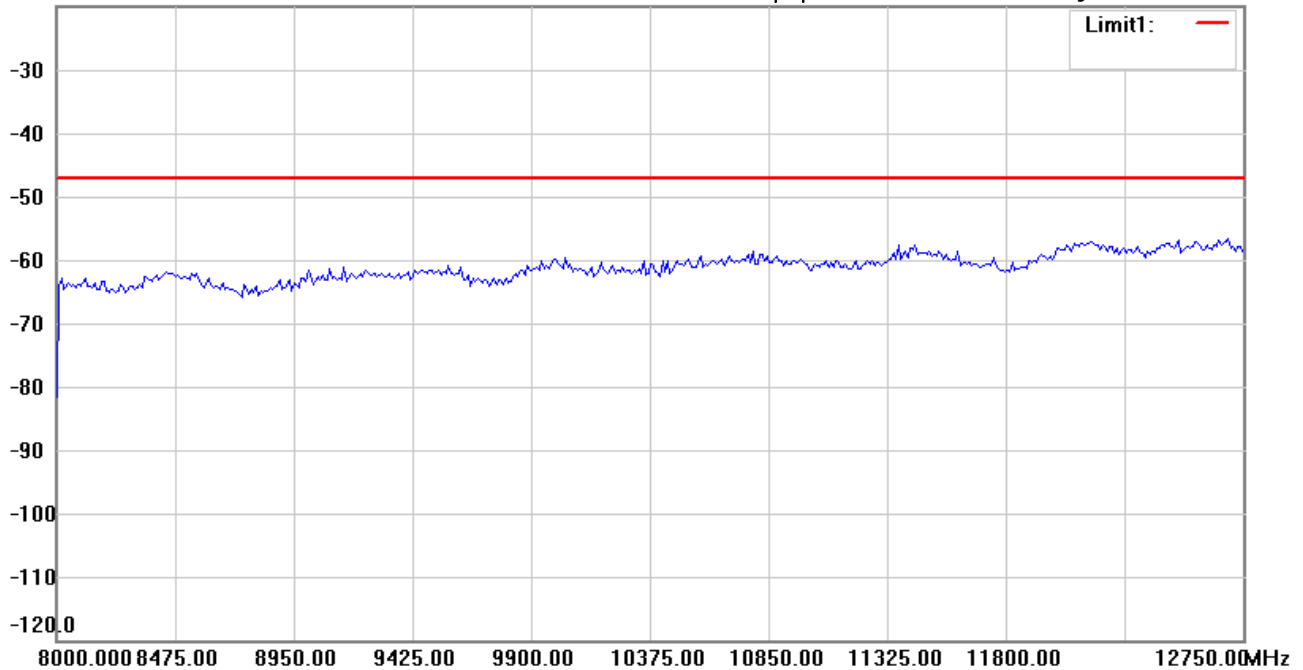
Data : #3

Condition : ETSI EN300\_328-RX\_Spurious\_N

Test Mode : RX CH39

Polarization: *Horizontal*

Distance: 3m

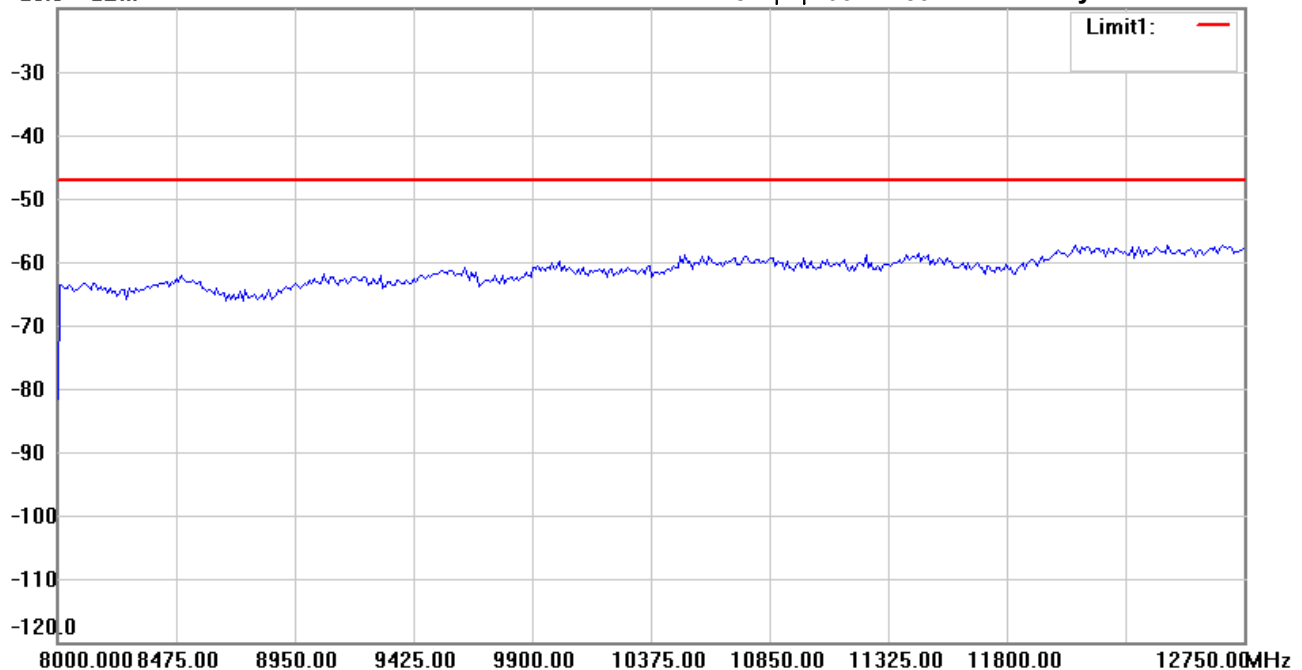
Data : #6

Condition : ETSI EN300\_328-RX\_Spurious\_N

Test Mode : RX CH39

Polarization: *Vertical*

Distance: 3m
